Home Report

1 WOLSELEY CRESCENT
WILLOWBRAE
EDINBURGH
EH8 7DF

Energy Performance Certificate (EPC)

1 WOLSELEY CRESCENT, WILLOWBRAE, EDINBURGH, EH8 7DF

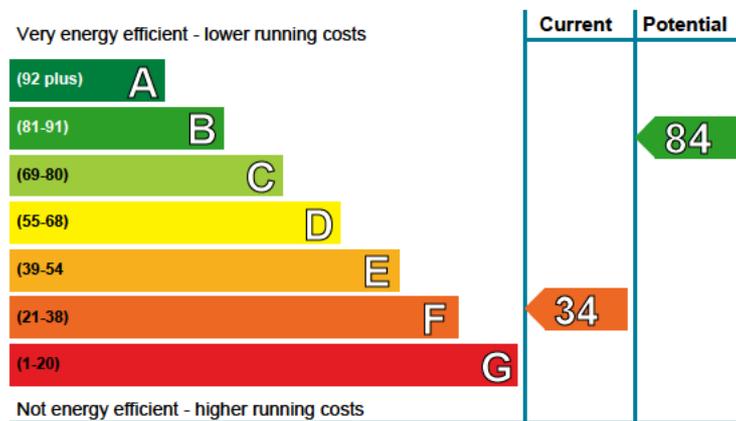
Energy Efficiency Rating

This graph shows the current efficiency of your home, taking into account both energy efficiency and fuel costs. The higher this rating, the lower your fuel bills are likely to be.

Your current rating is **band F (34)**. The average rating for EPCs in Scotland is **band D (61)**.

The potential rating shows the effect of undertaking all of the improvement measures listed within your recommendations report.

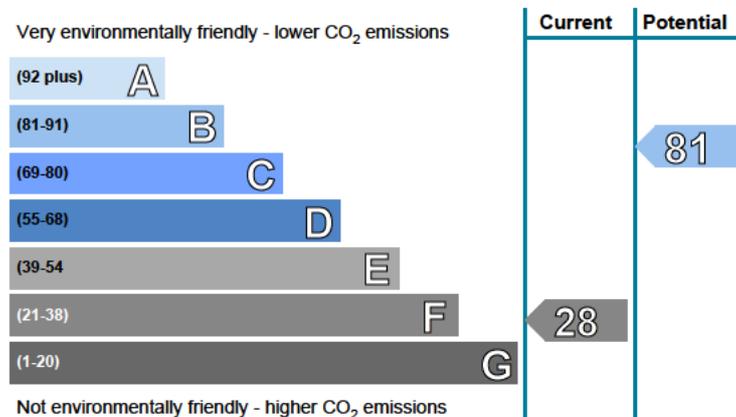
Environmental Impact (CO₂) Rating

This graph shows the effect of your home on the environment in terms of carbon dioxide (CO₂) emissions. The higher the rating, the less impact it has on the environment.

Your current rating is **band F (28)**. The average rating for EPCs in Scotland is **band D (59)**.

The potential rating shows the effect of undertaking all of the improvement measures listed within your recommendations report.

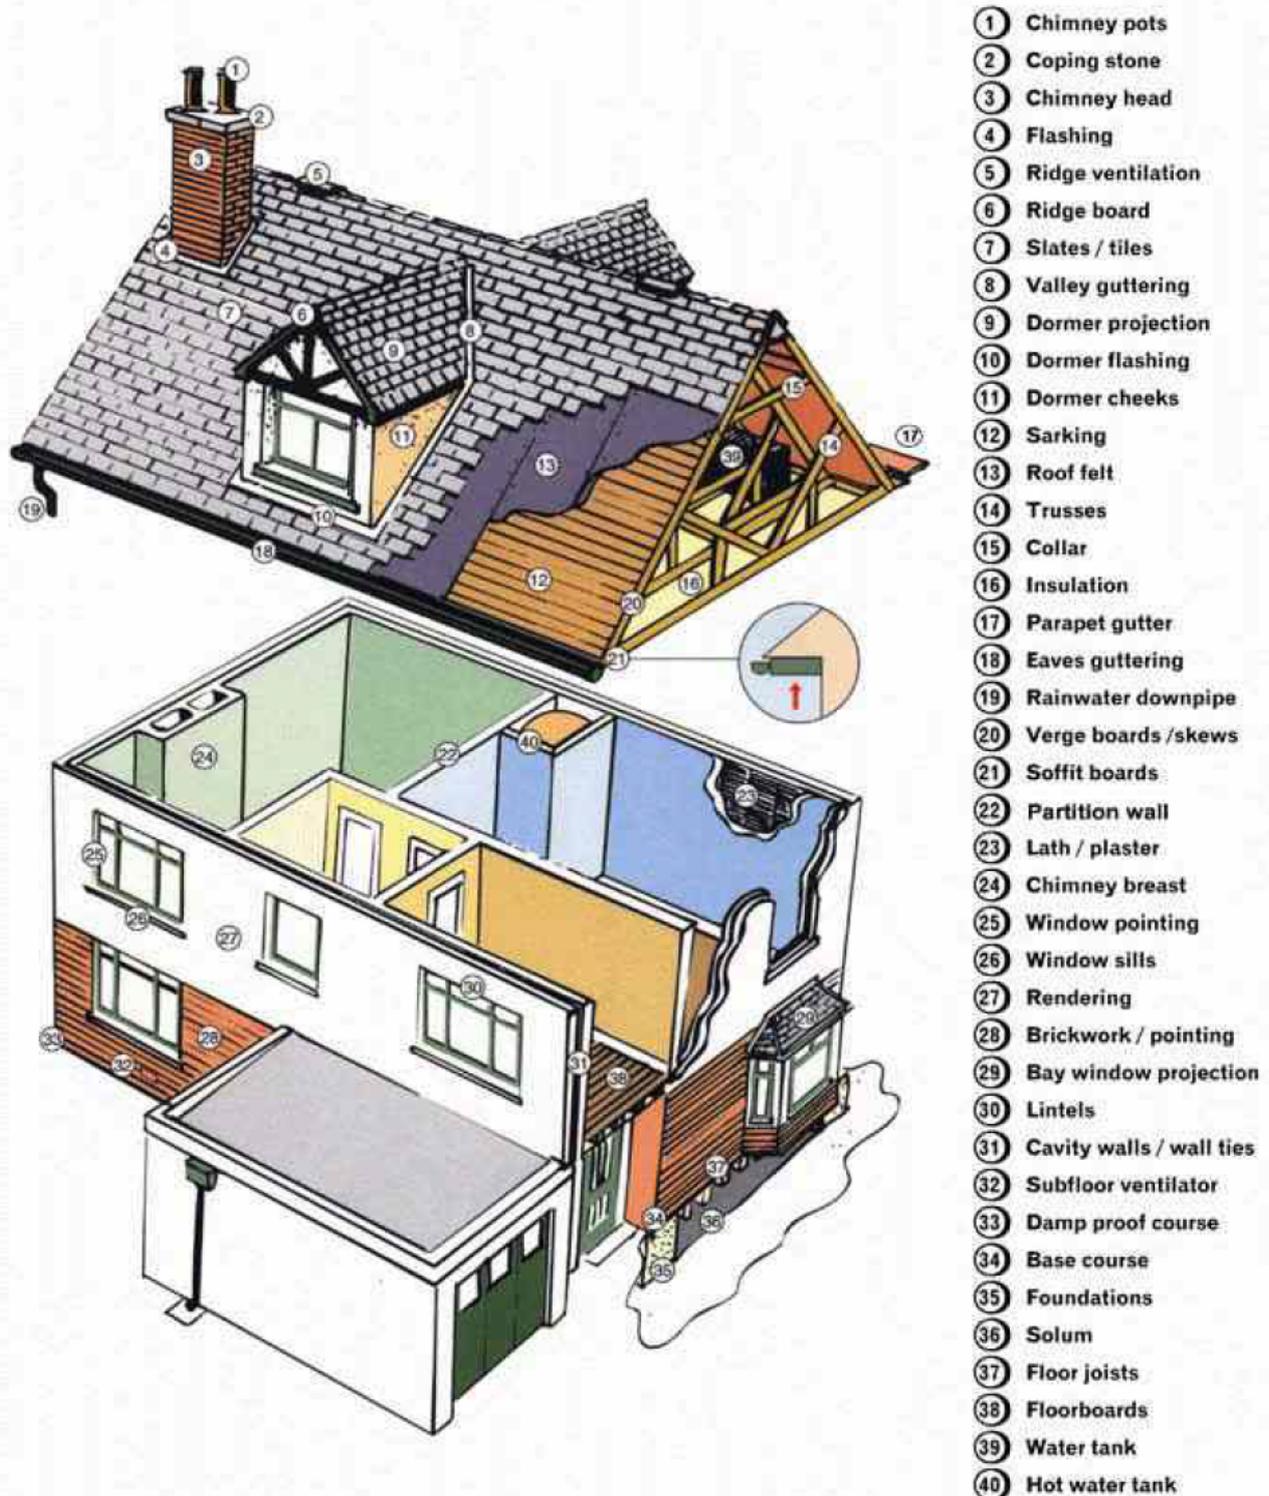
Sectional Diagram showing elements of a typical house

Reference may be made in this report to some or all of the above component parts of the property. This diagram may assist you in locating and understanding these items.
